AERIAL PHOTOGRAPHIC ANALYSIS OF THE LARSON AFB STUDY AREA Moses Lake, Washington

EPA Region 10

TS-PIC-89818/90818-1
November 1989

M. A. Finkbeiner
Environmental Programs
Lockheed Engineering and Sciences Company
Las Vegas, Nevada 89193-3478

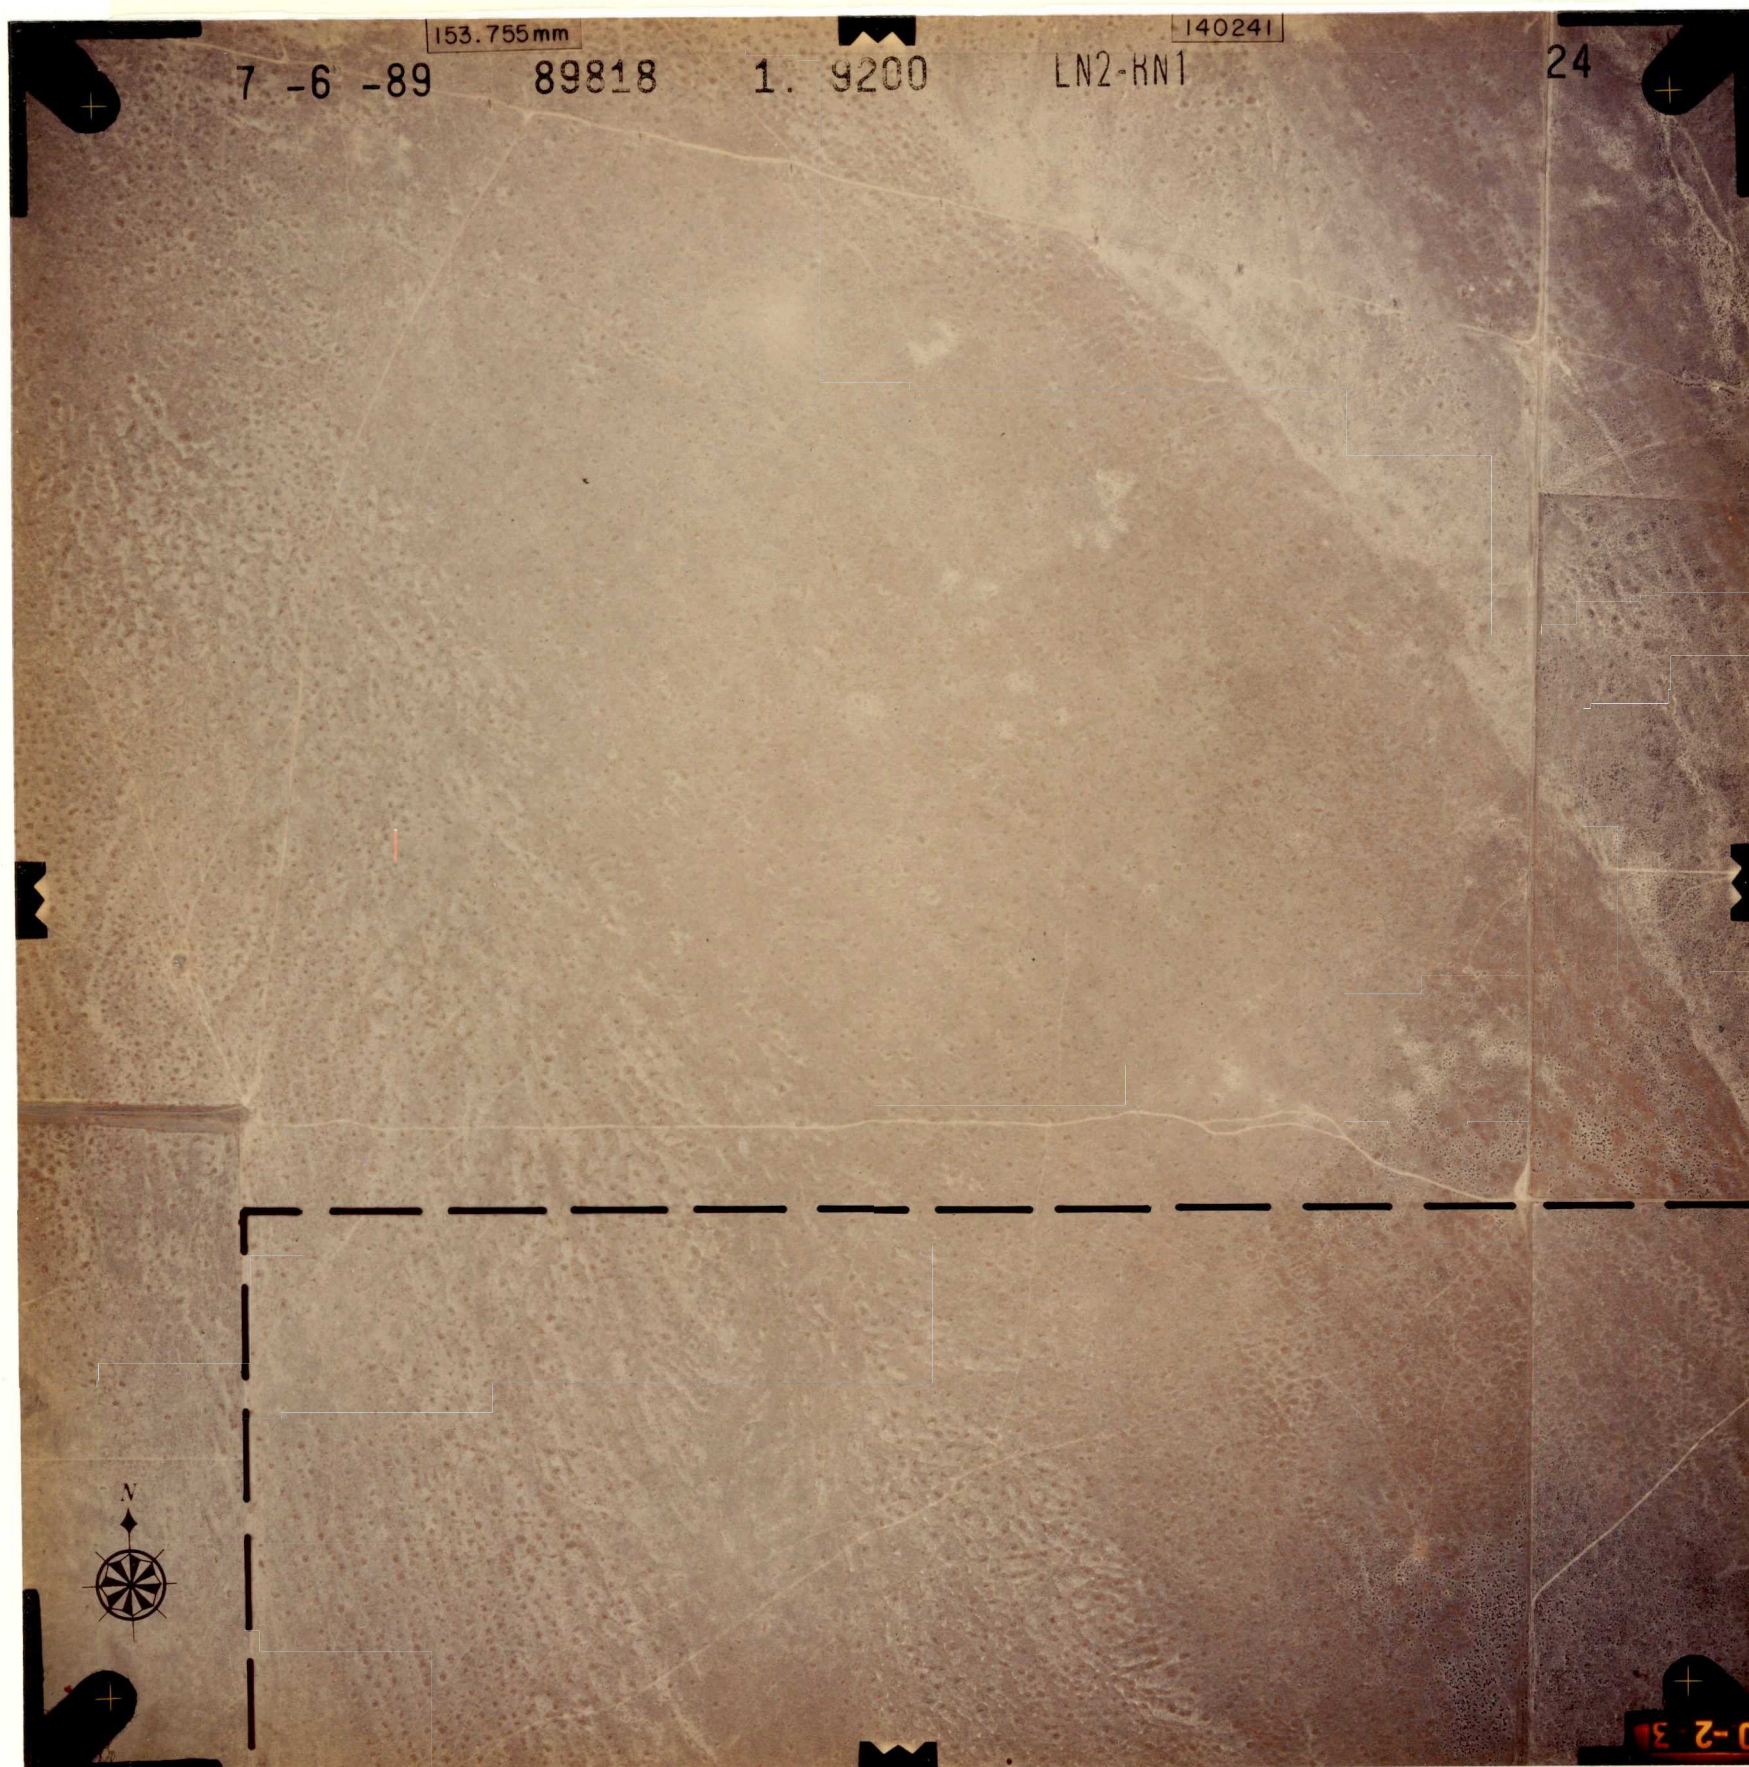
Figure 11. Larson AFB study area, July 6, 1989 (1 of 20). Approximate scale 1:9,200.

Figure 11 shows the northwest corner of the study area. No activity of any kind is visible in this area, which consists of undisturbed desert.

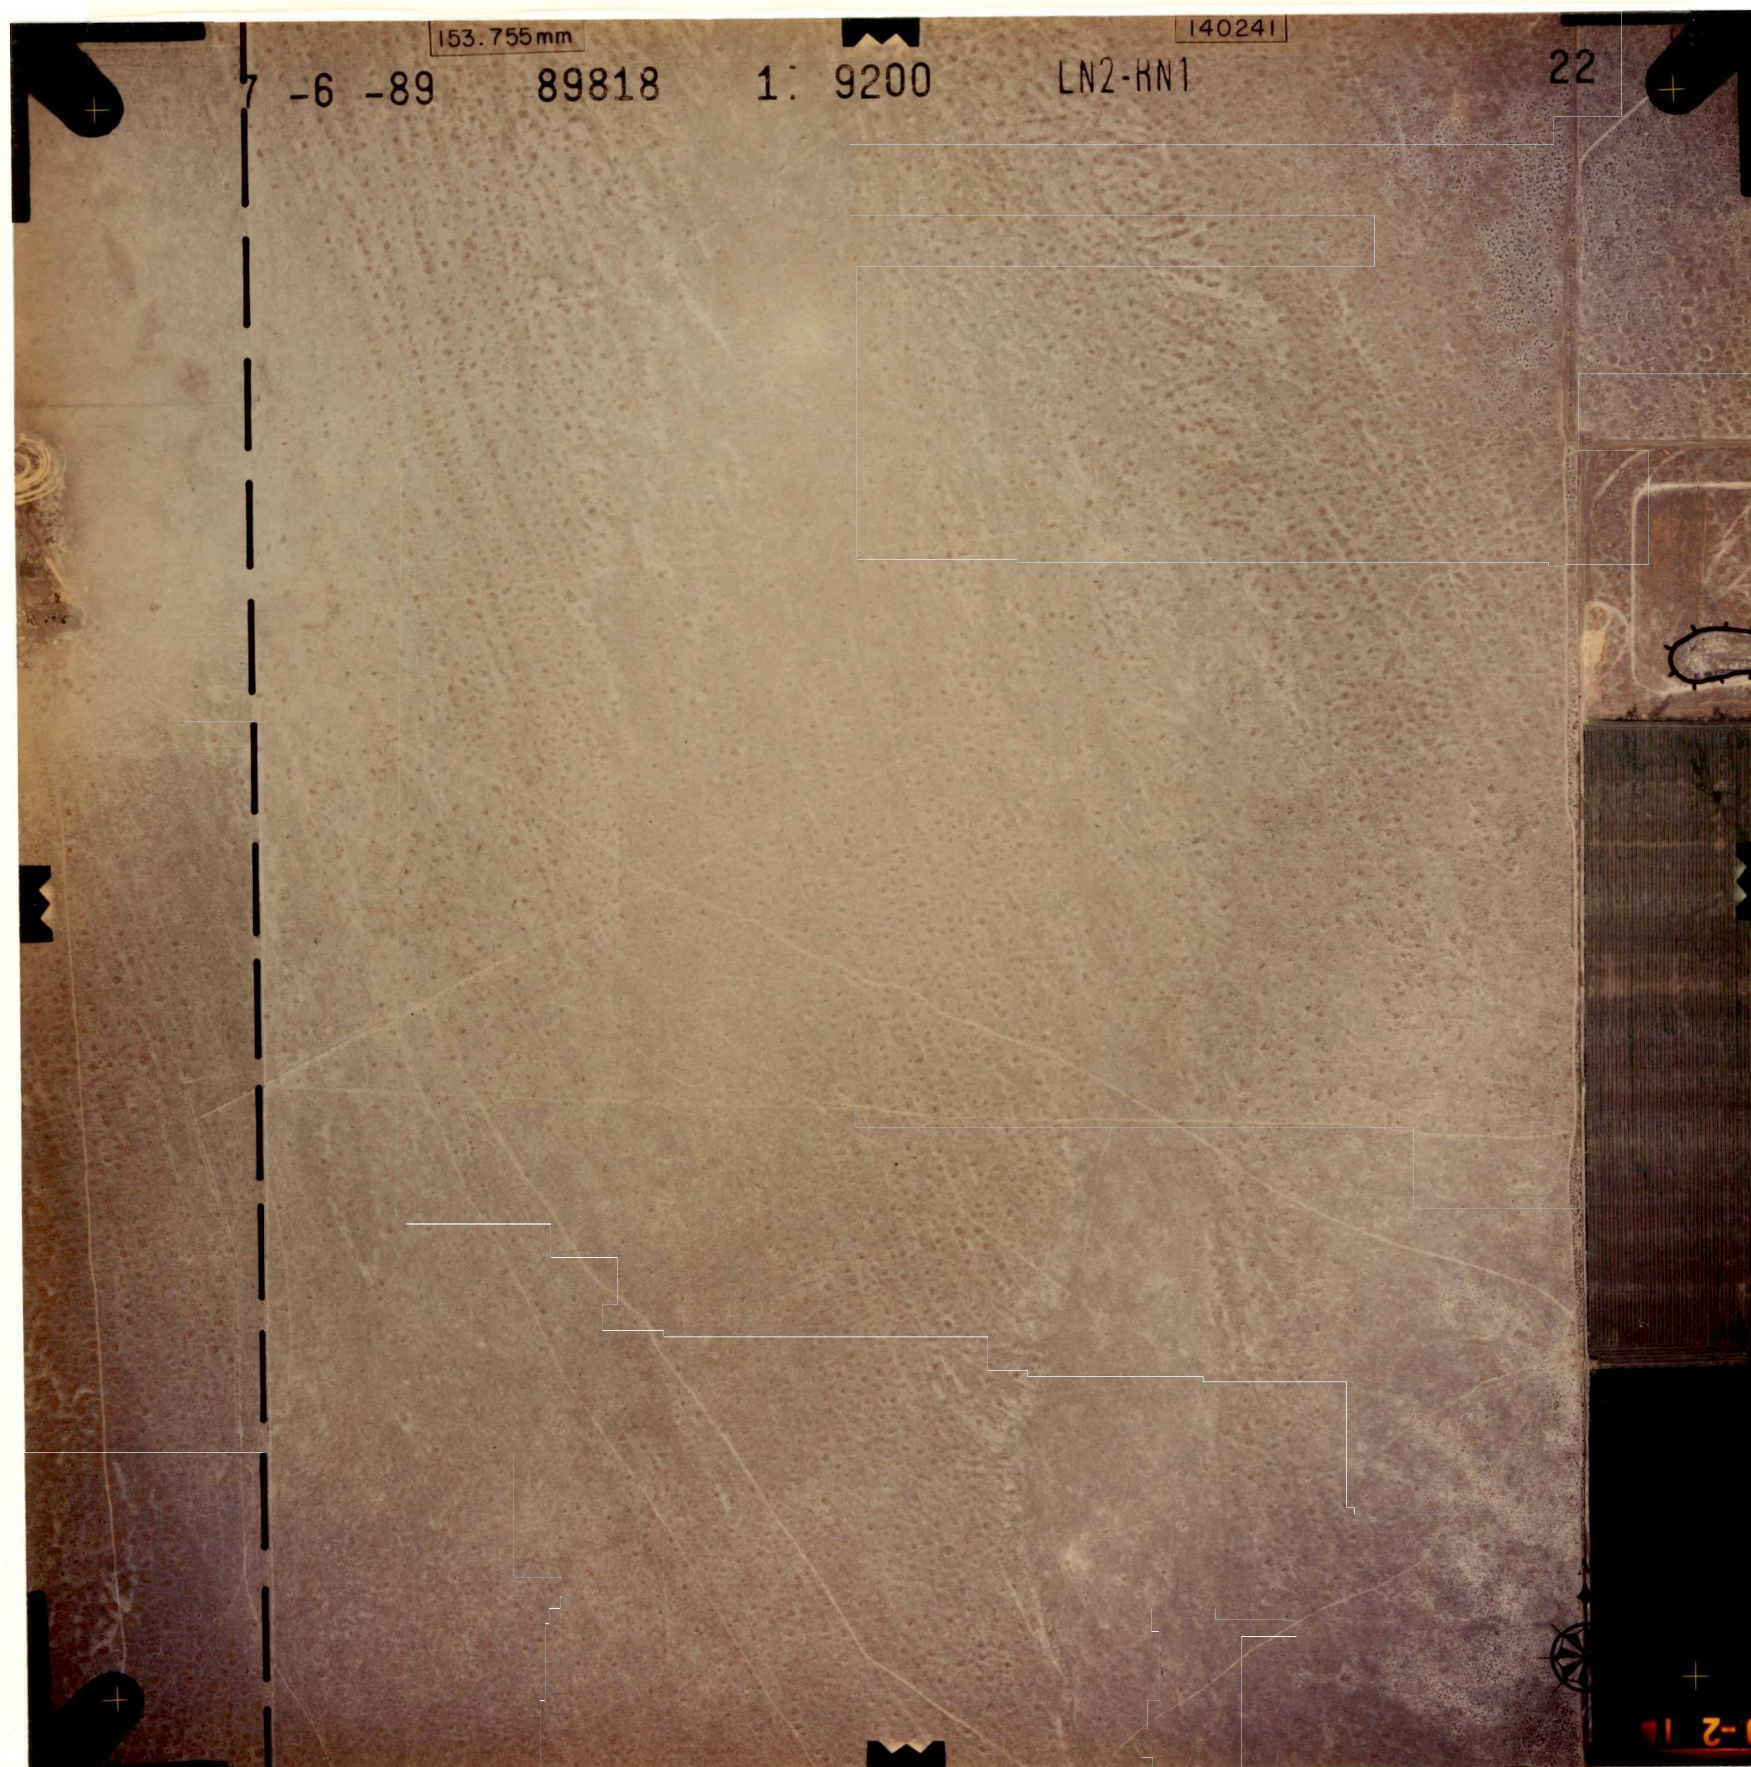
Figure 12. Larson AFB study area, July 6, 1989 (2 of 20). Approximate scale 1:9,200.

Figure 12 shows the western edge of an agricultural field which corresponds to the military reservation boundary. No other activity is visible.

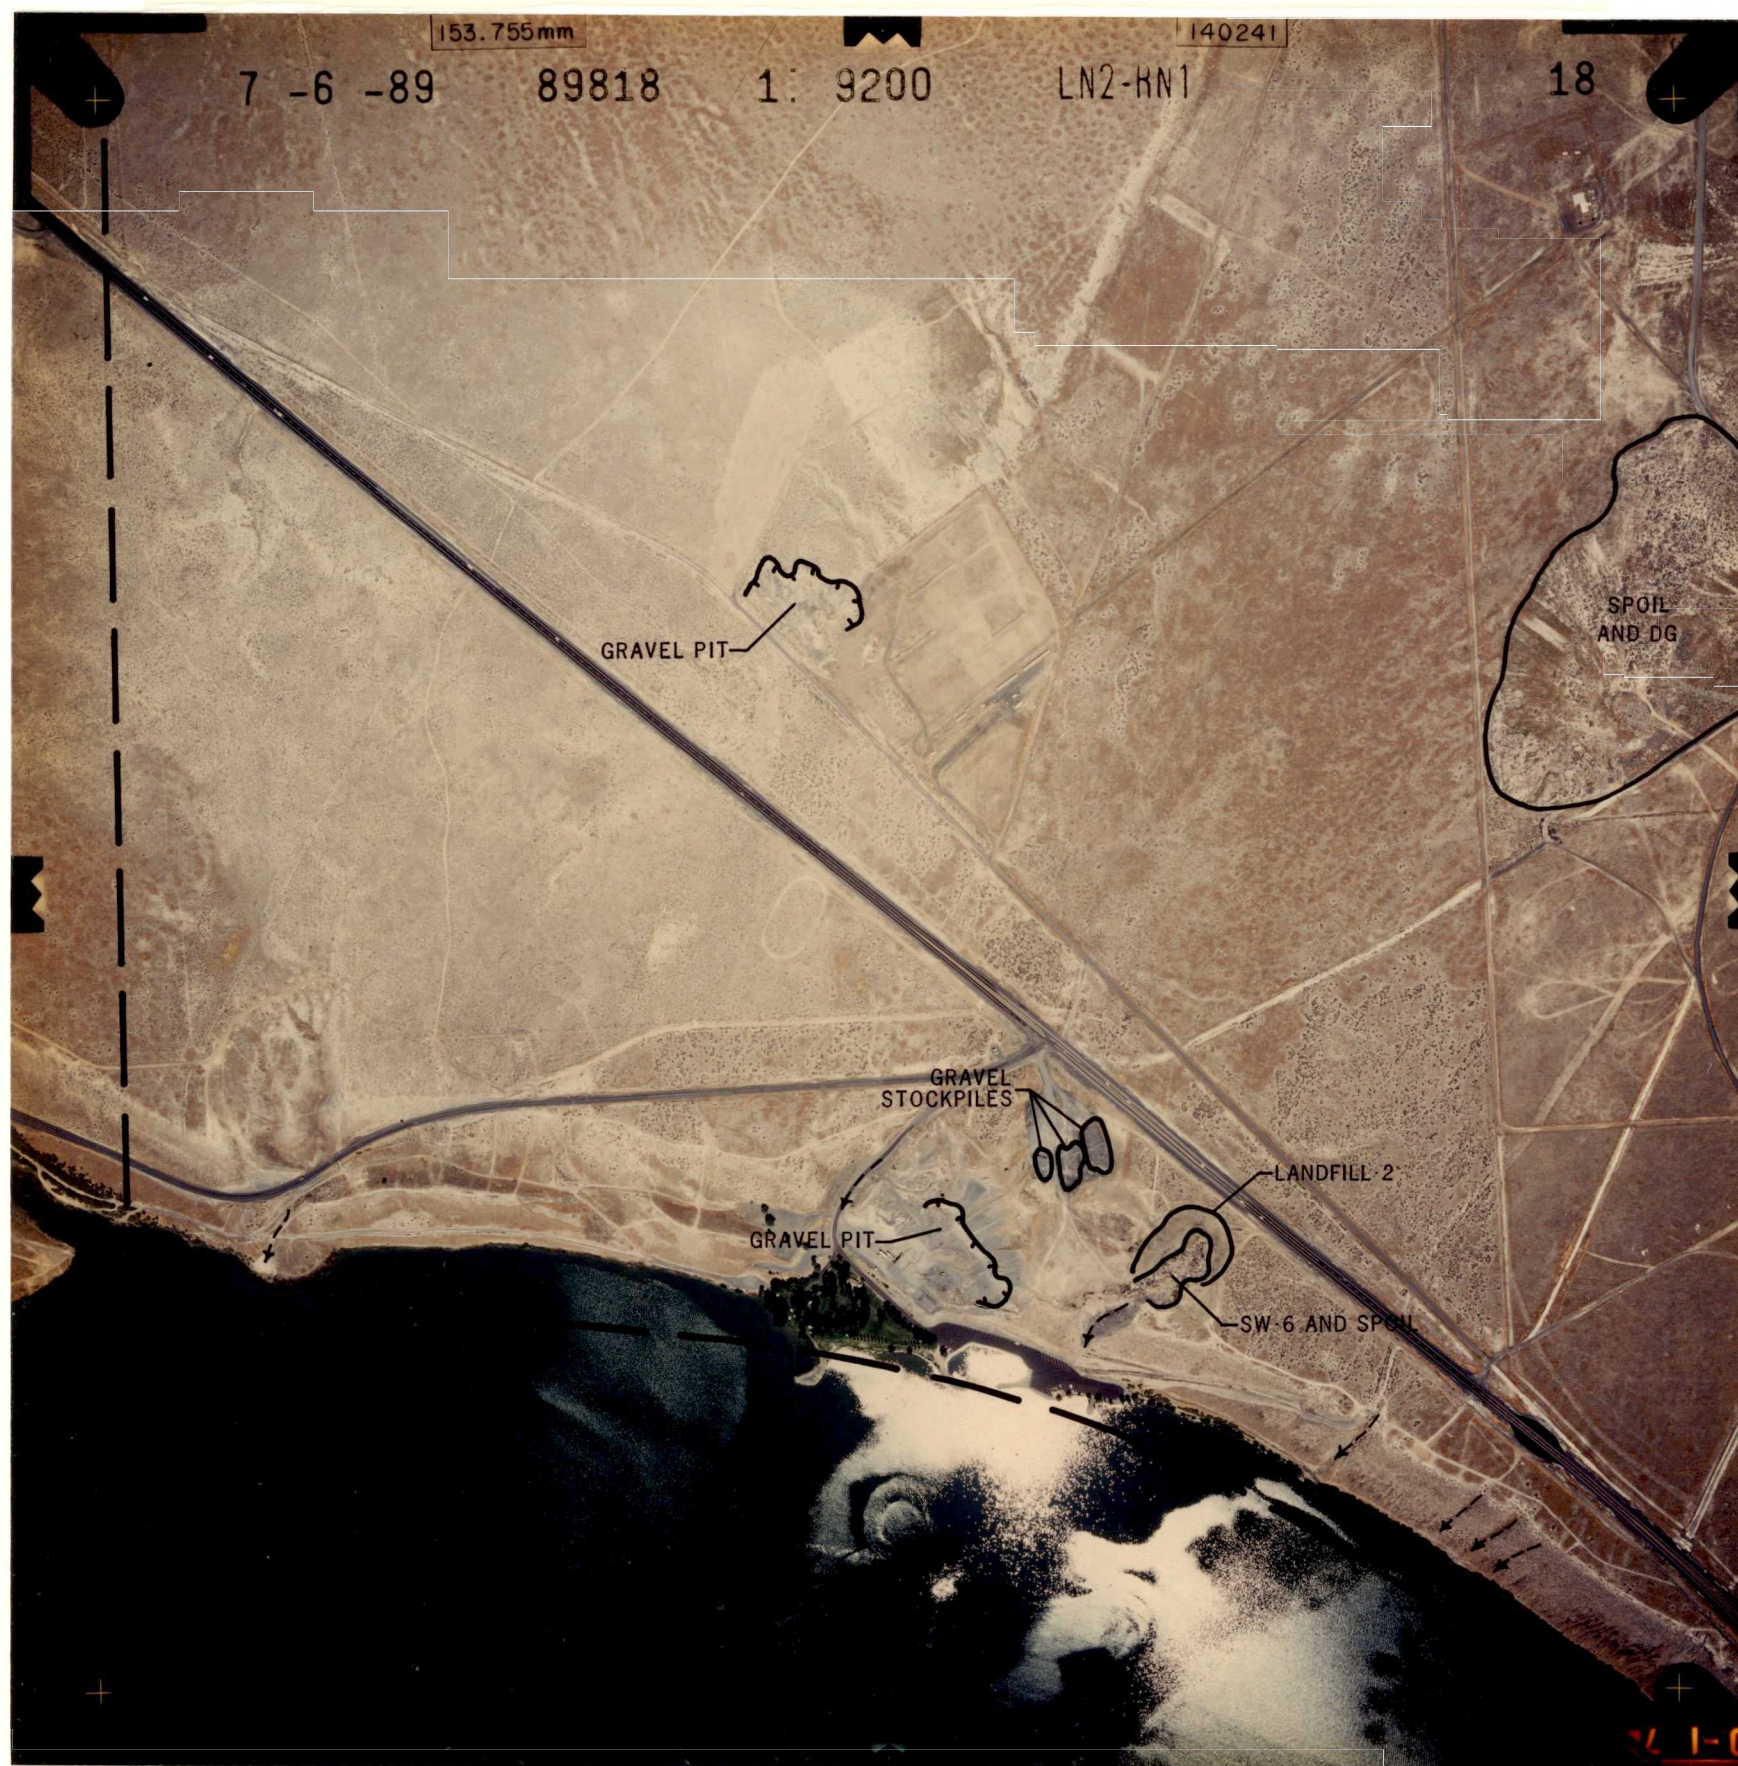
SW-6 & Spoil: A significant accumulation of mixed spoil and solid waste is noted at this location. Much of the spoil appears to be concrete construction rubble. Several metal objects of various sizes are also visible. The presence of vegetation on most of the spoil suggests that little new disposal has occurred for some time. Drainage from this area is directly to Moses Lake via the parking lot to the south.

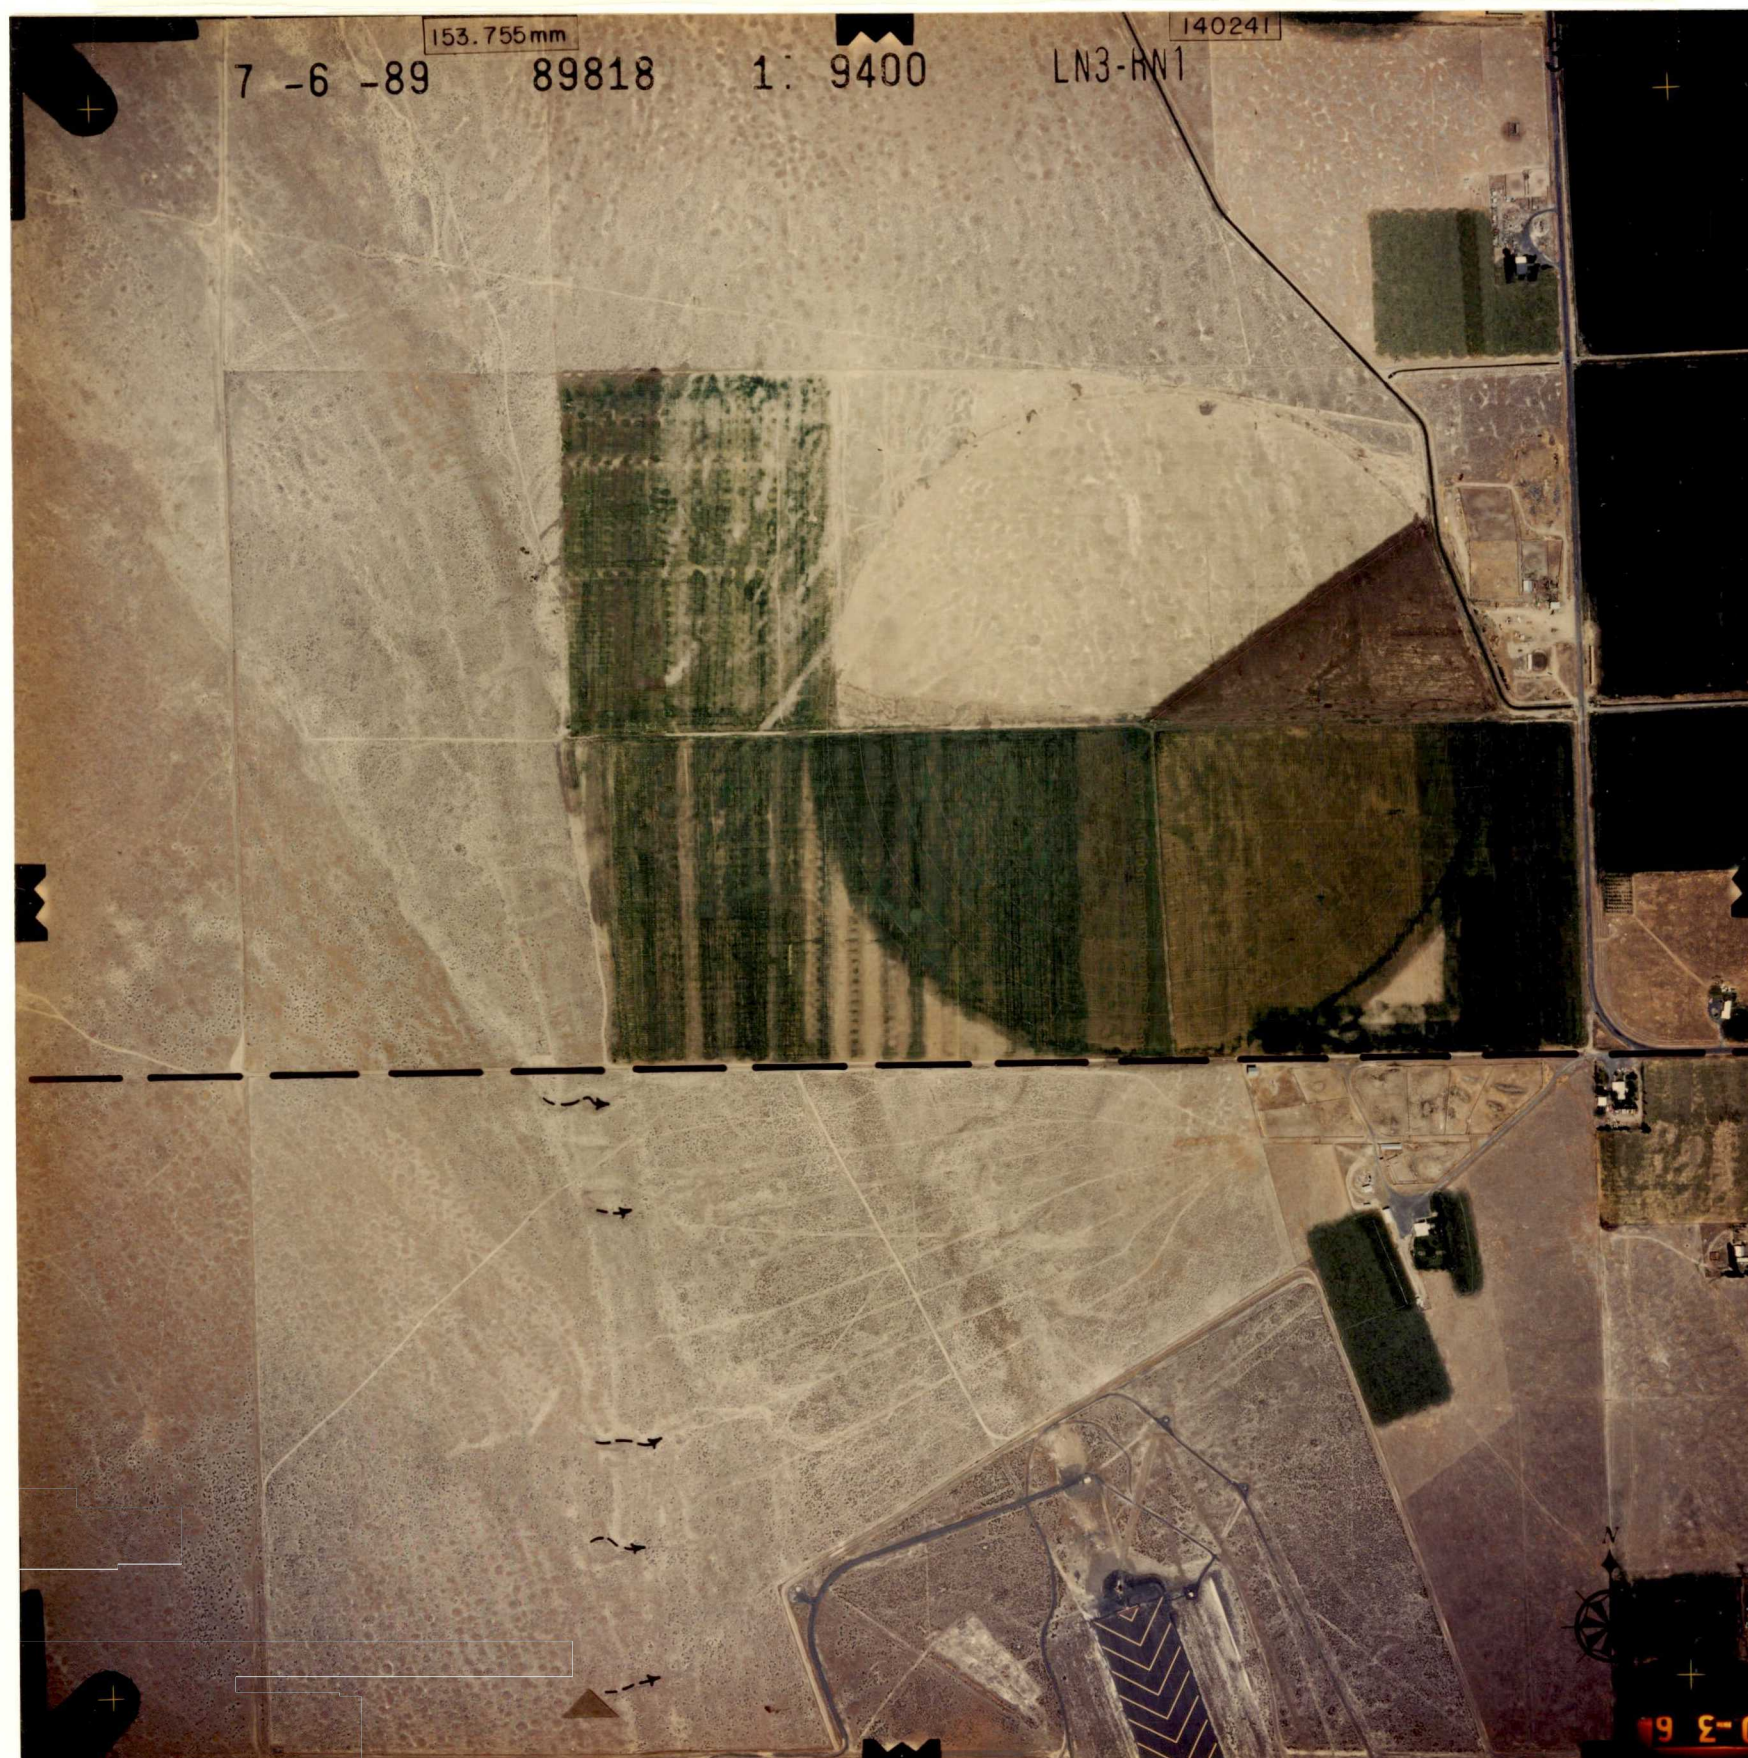
Figure 15. Larson AFB study area, July 6, 1989 (5 of 20). Approximate scale 1:9,400.

Figure 15 shows the north end of the main runway at the airport. What appear to be feedlots and an irrigation area are the only active operations noted on this frame. No potential environmental hazards are evident.

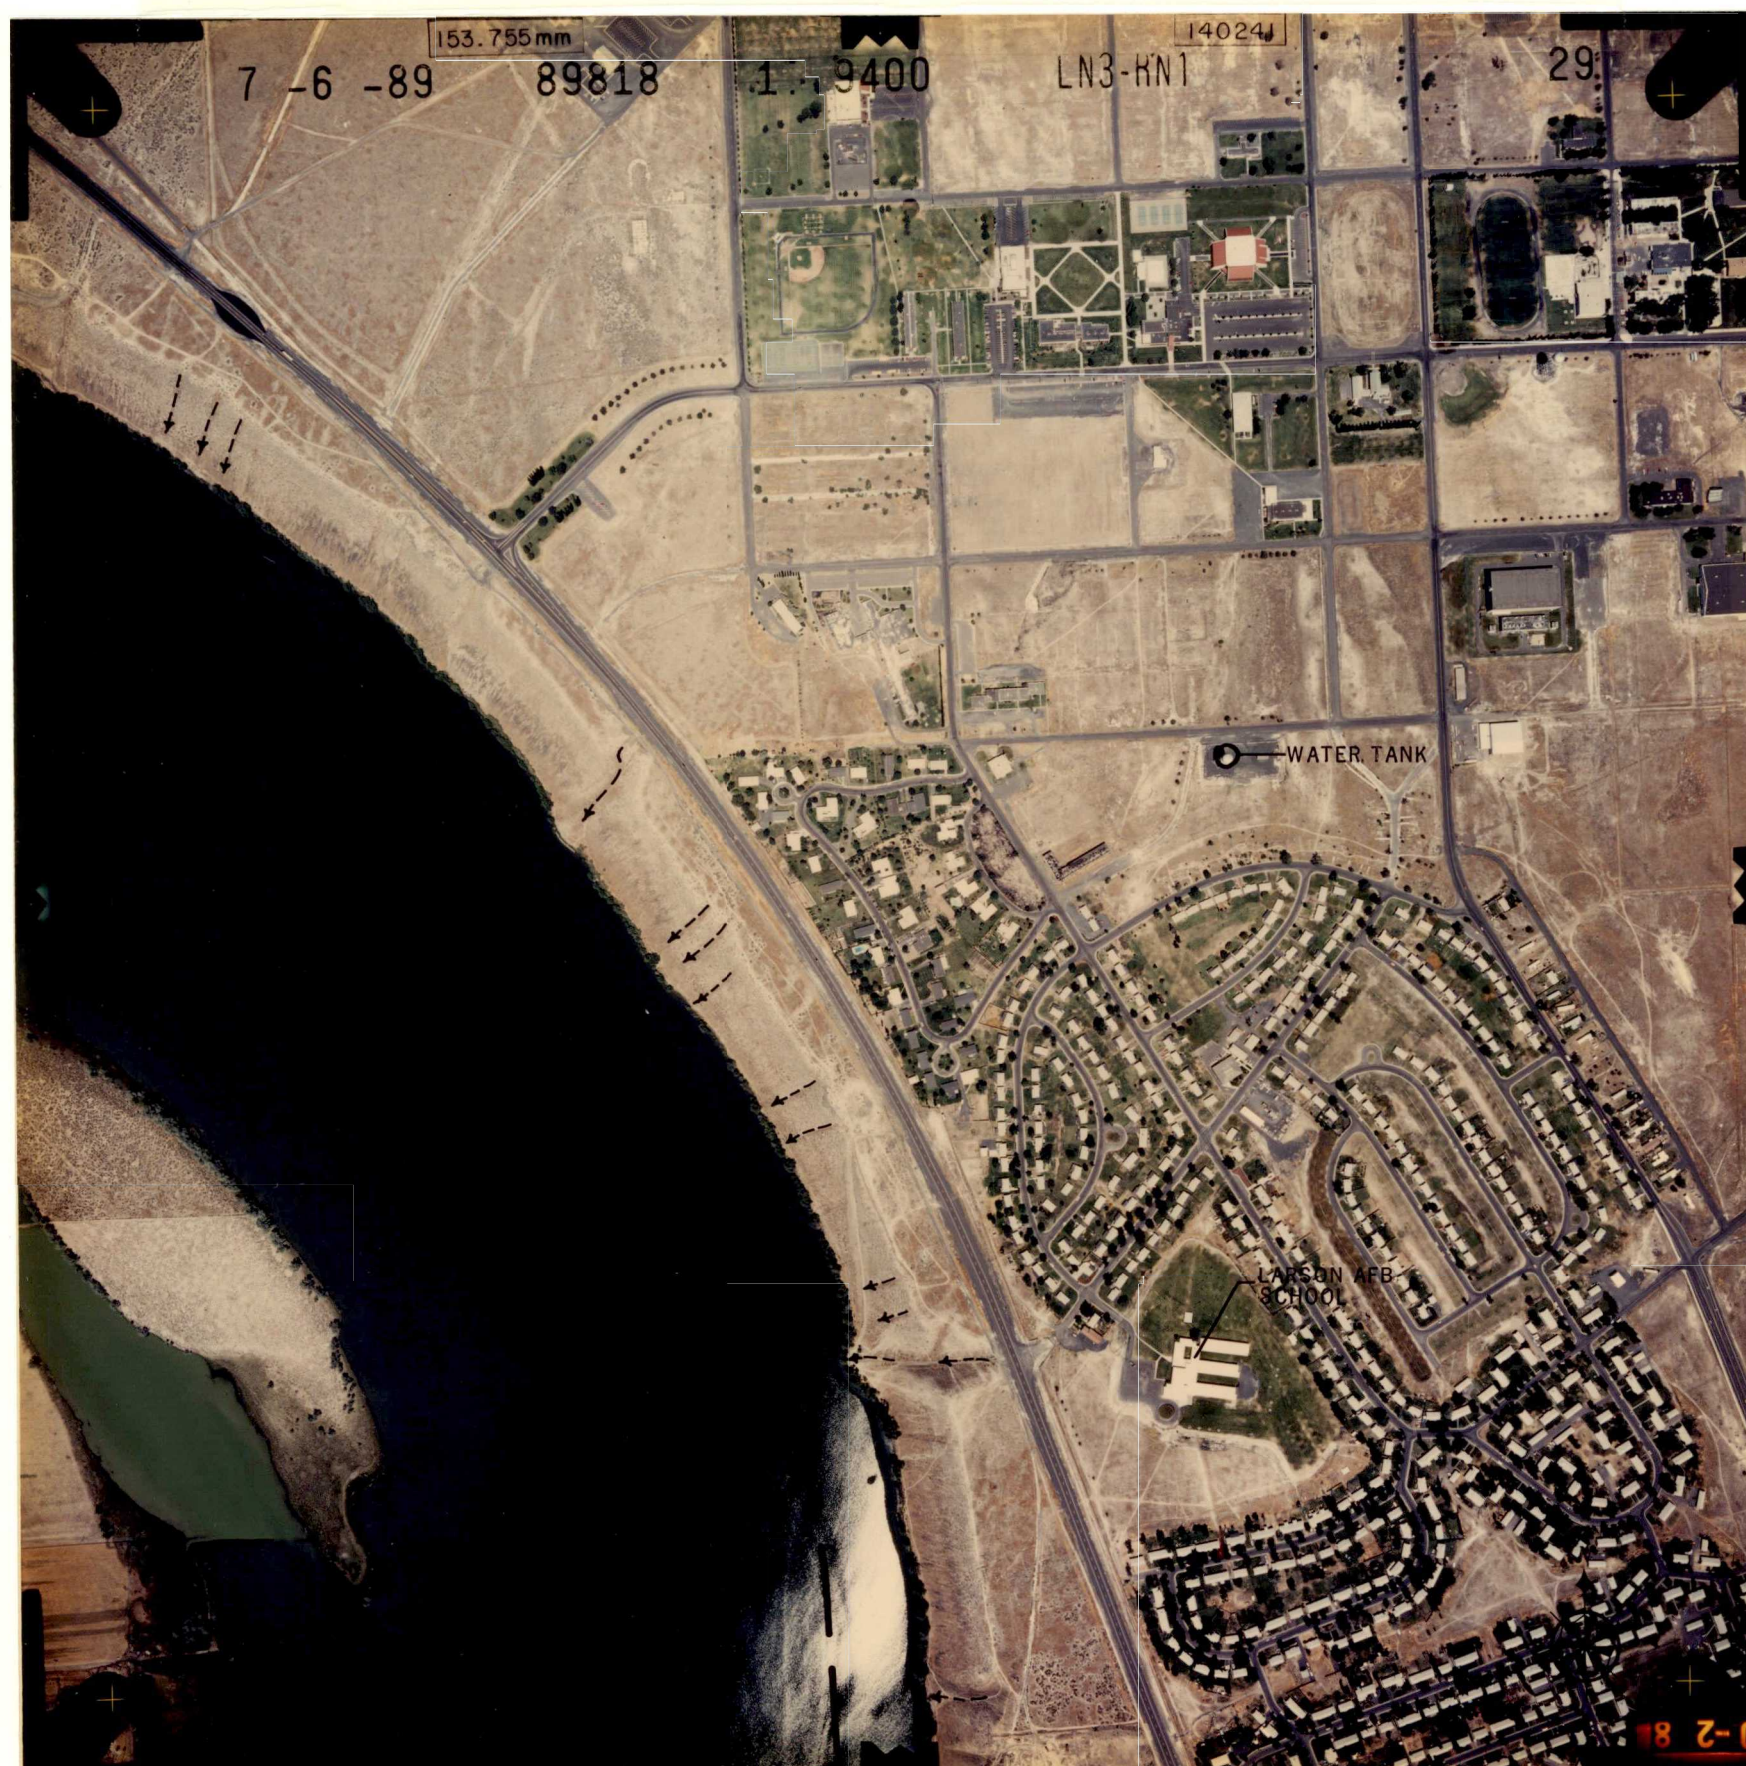
Figure 19. Larson AFB study area, July 6, 1989 (9 of 20). Approximate scale 1:9,400.

Figure 19 shows no significant change from 1973, and no potential environmental hazards are visible.

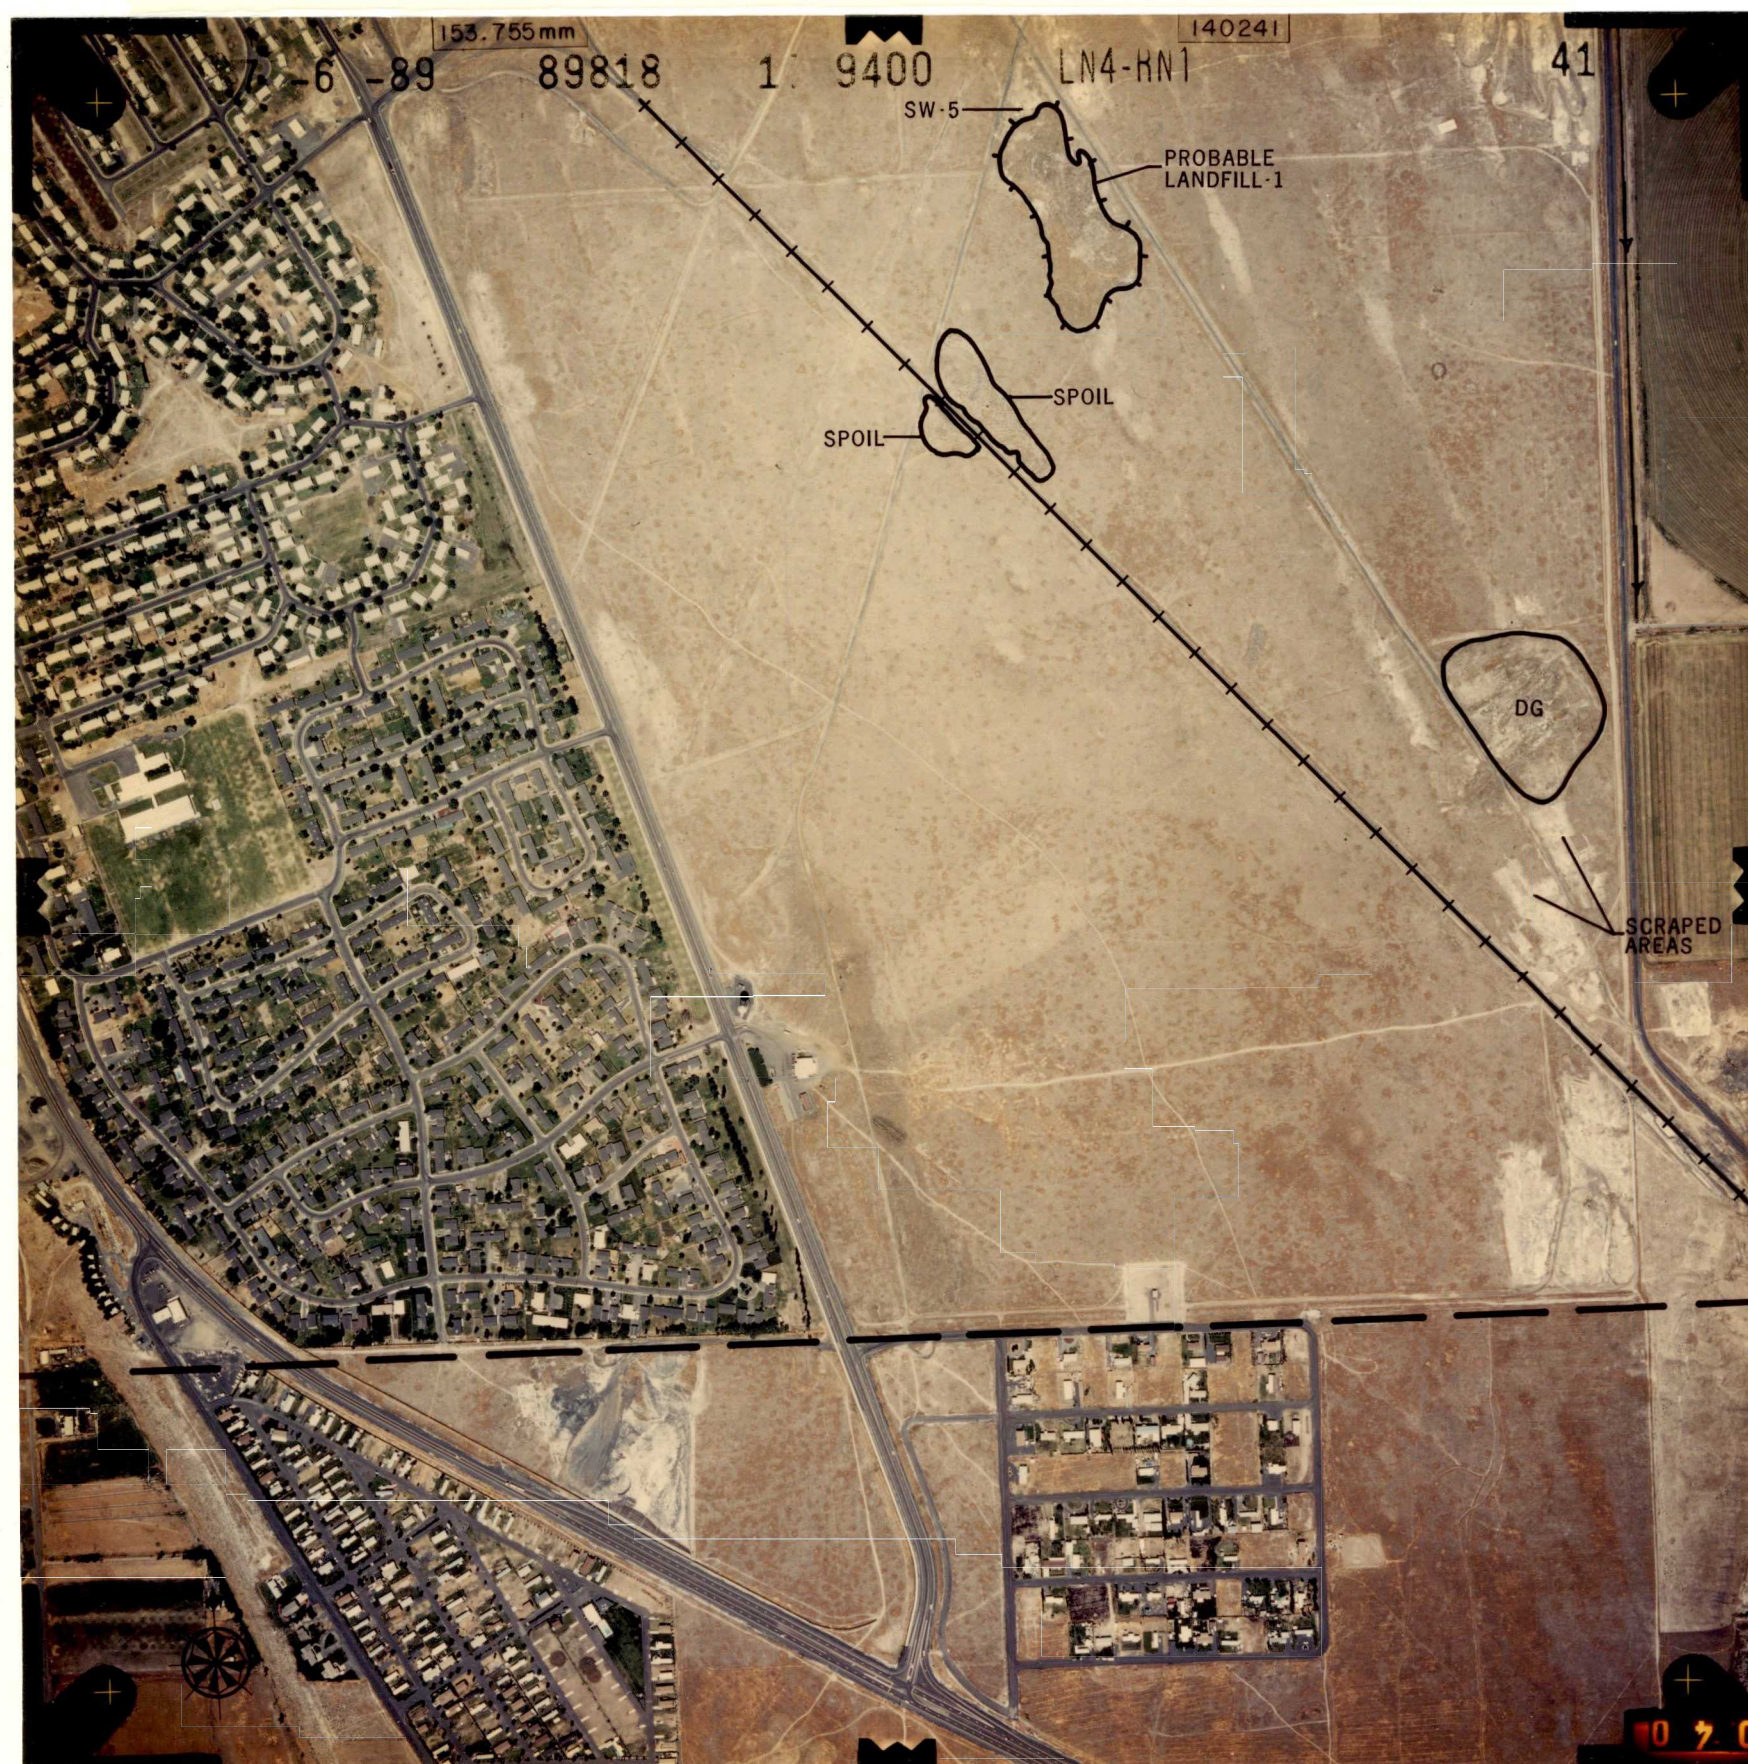
JULY 6, 1989 (15 of 20)

No change is evident in this part of the study area. The disturbed ground in the east part of the frame shows signs of revegetation.

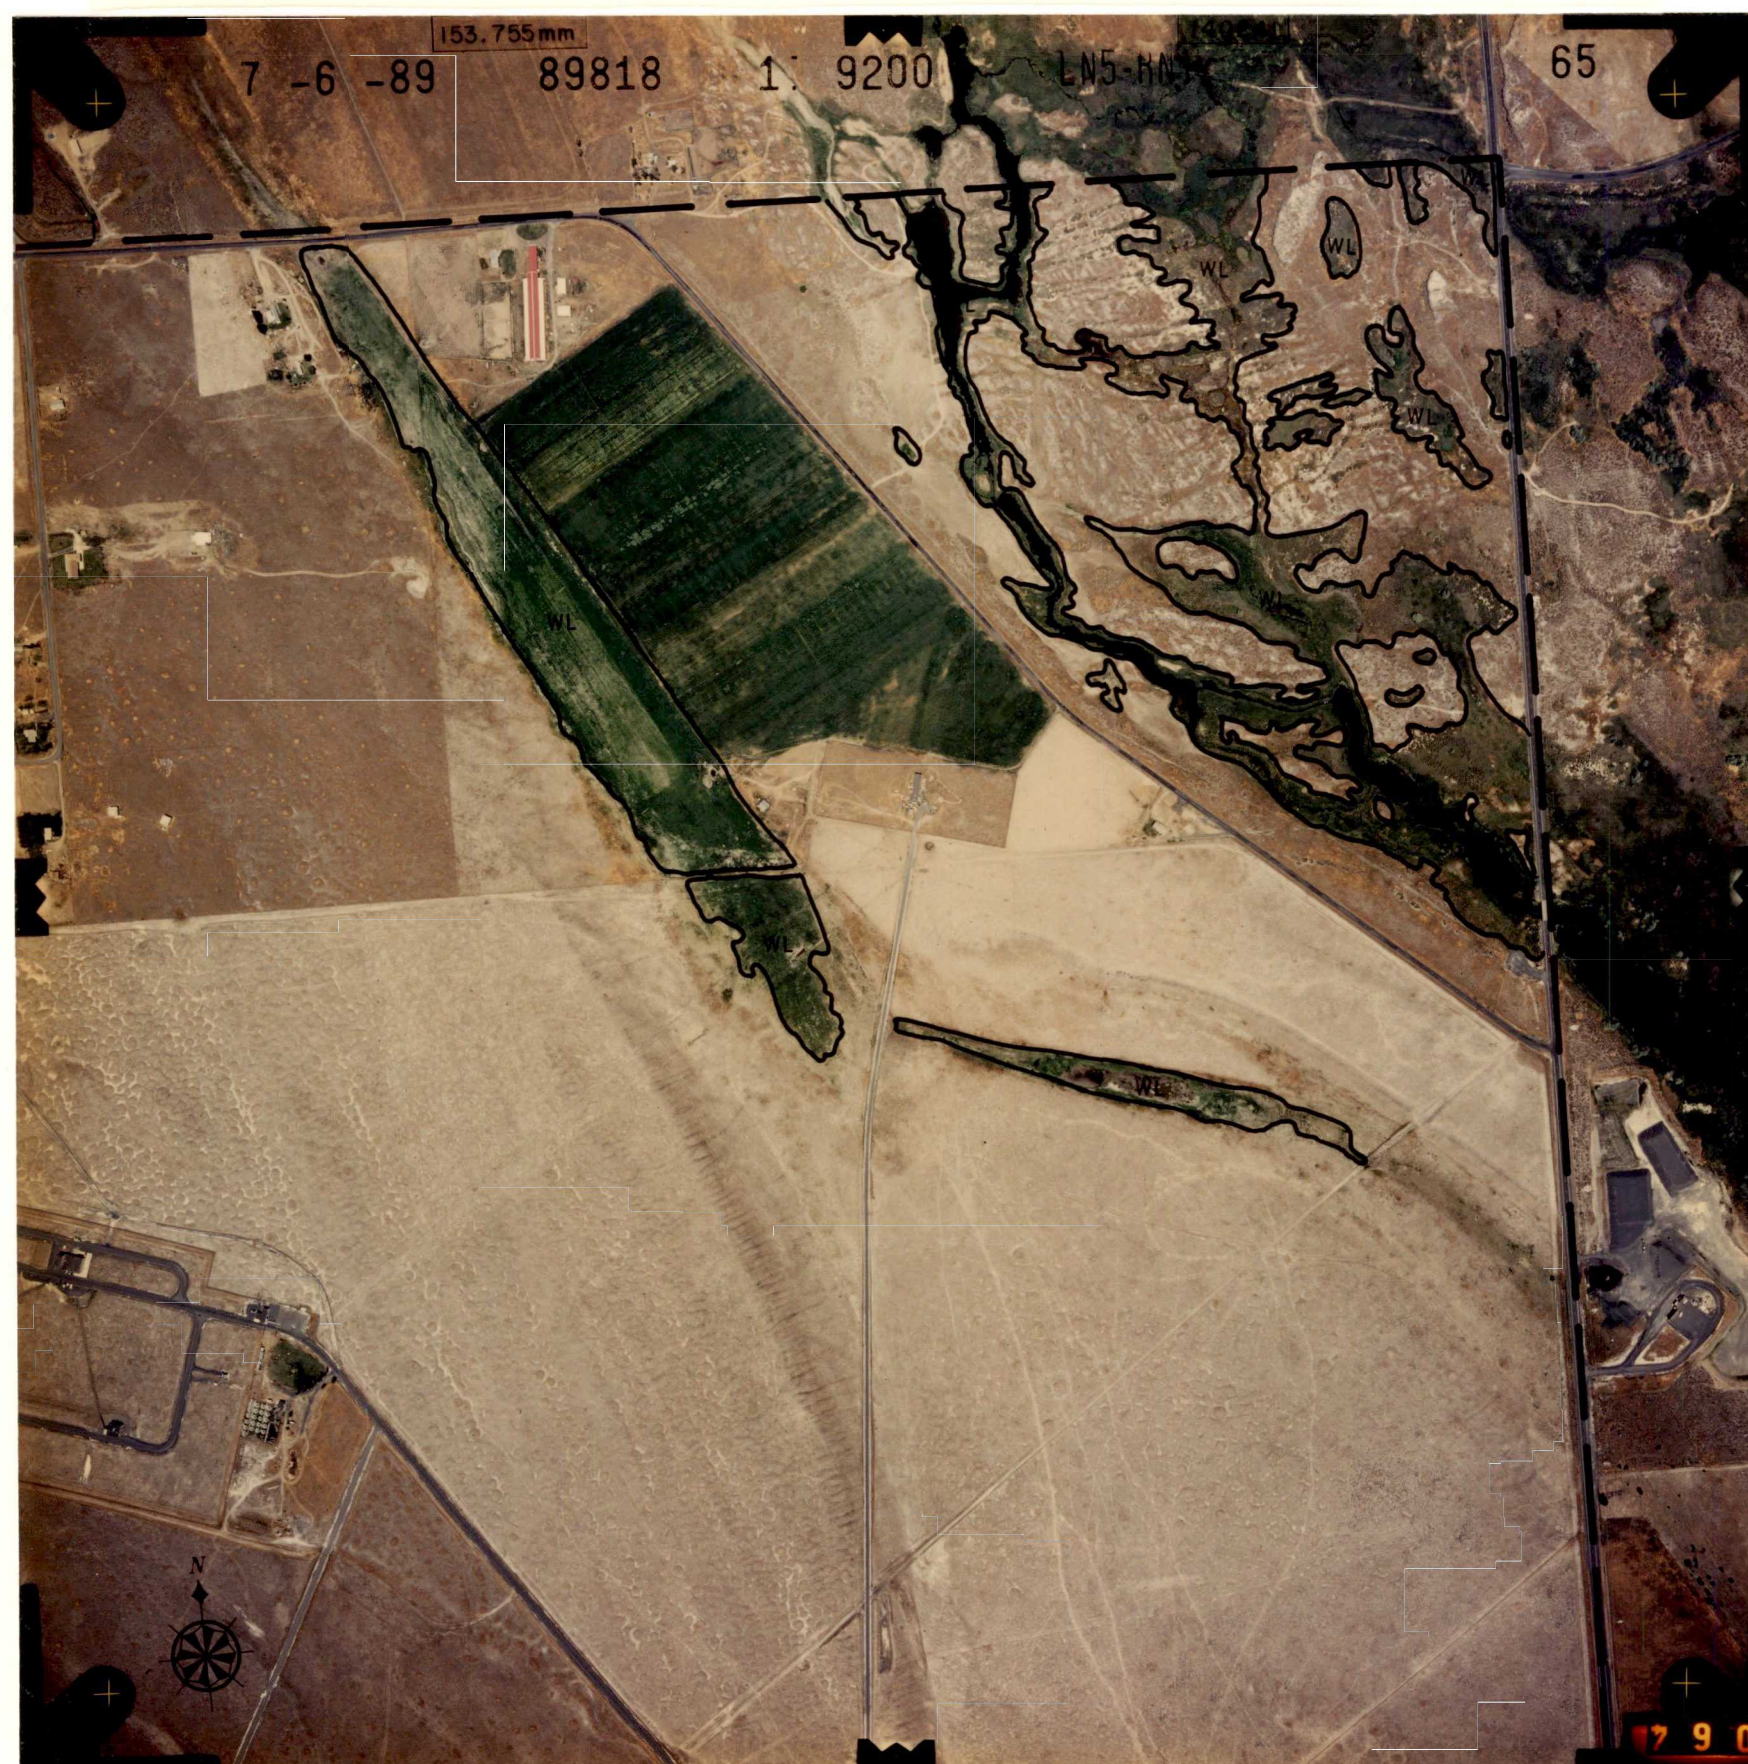
Figure 26. Larson AFB study area, July 6, 1989 (16 of 20). Approximate scale 1:9,200.

Figure 26 shows the northeast corner of the study area. No significant activity was observed in this area in 1973 and none is evident on the 1989 photography. An extensive area of riparian wetlands are visible in the Crab Creek drainage, and wetland vegetation is also located in an old slough southwest of an irrigated area.
